## why choose **vebro**deck PU ID?

Suited to internal parking decks, ramps & turning circles

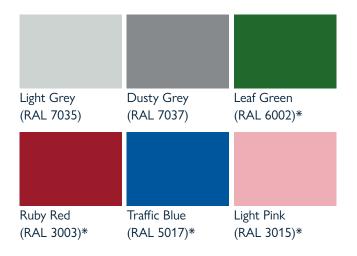
1 Primer	vebrodeck PU BC with 60 – 100s mesh sand	0.45 kg/m² 0.15 kg/m²
2 Scatter	30 – 60s mesh sand	2.50 kg/m <sup>2</sup>
3 Coating	vebrodeck PU TC	0.50 kg/m <sup>2</sup>
4 Seal	vebro PU UV Seal (Gloss) or vebro PU UV WB Seal (Gloss)	0.12 kg/m²

Thickness	1.5 mm
Speed of Cure (at 25°C)	Light Foot Traffic – 18 – 36 hours Full Chemical Cure – 28 days
Abrasion Resistance EN 13892-4 / BS 8204-2	AR 0.5 / Special Class
<b>Abrasion Resistance</b> <i>EN ISO 5470-1</i>	1.9 mg / 1000 U (≤ 3.000)
Impact Resistance EN ISO 6772-2	4 Nm (no cracks)
Chemical Resistance	Resistant to a very wide range of chemicals. For a full chemical resistance breakdown contact our Technical Services team.
Adhesion EN ISO 4624	>1.5 N/mm² (concrete failure)
Fire Resistance EN ISO 13501	B <sub>ff</sub> -s1
Water Vapour Permeability EN ISO 7783-2	Class III >200 m
Water Absorption EN 1062-3	$<0.01 \text{ kg/m}^2 \times \text{h0.5}$
